TS-PIC-20305593S
JUNE 2003

AERIAL PHOTOGRAPHIC ANALYSIS OF N-FORCER SITE DEARBORN, MICHIGAN

Dearborn, Michigan

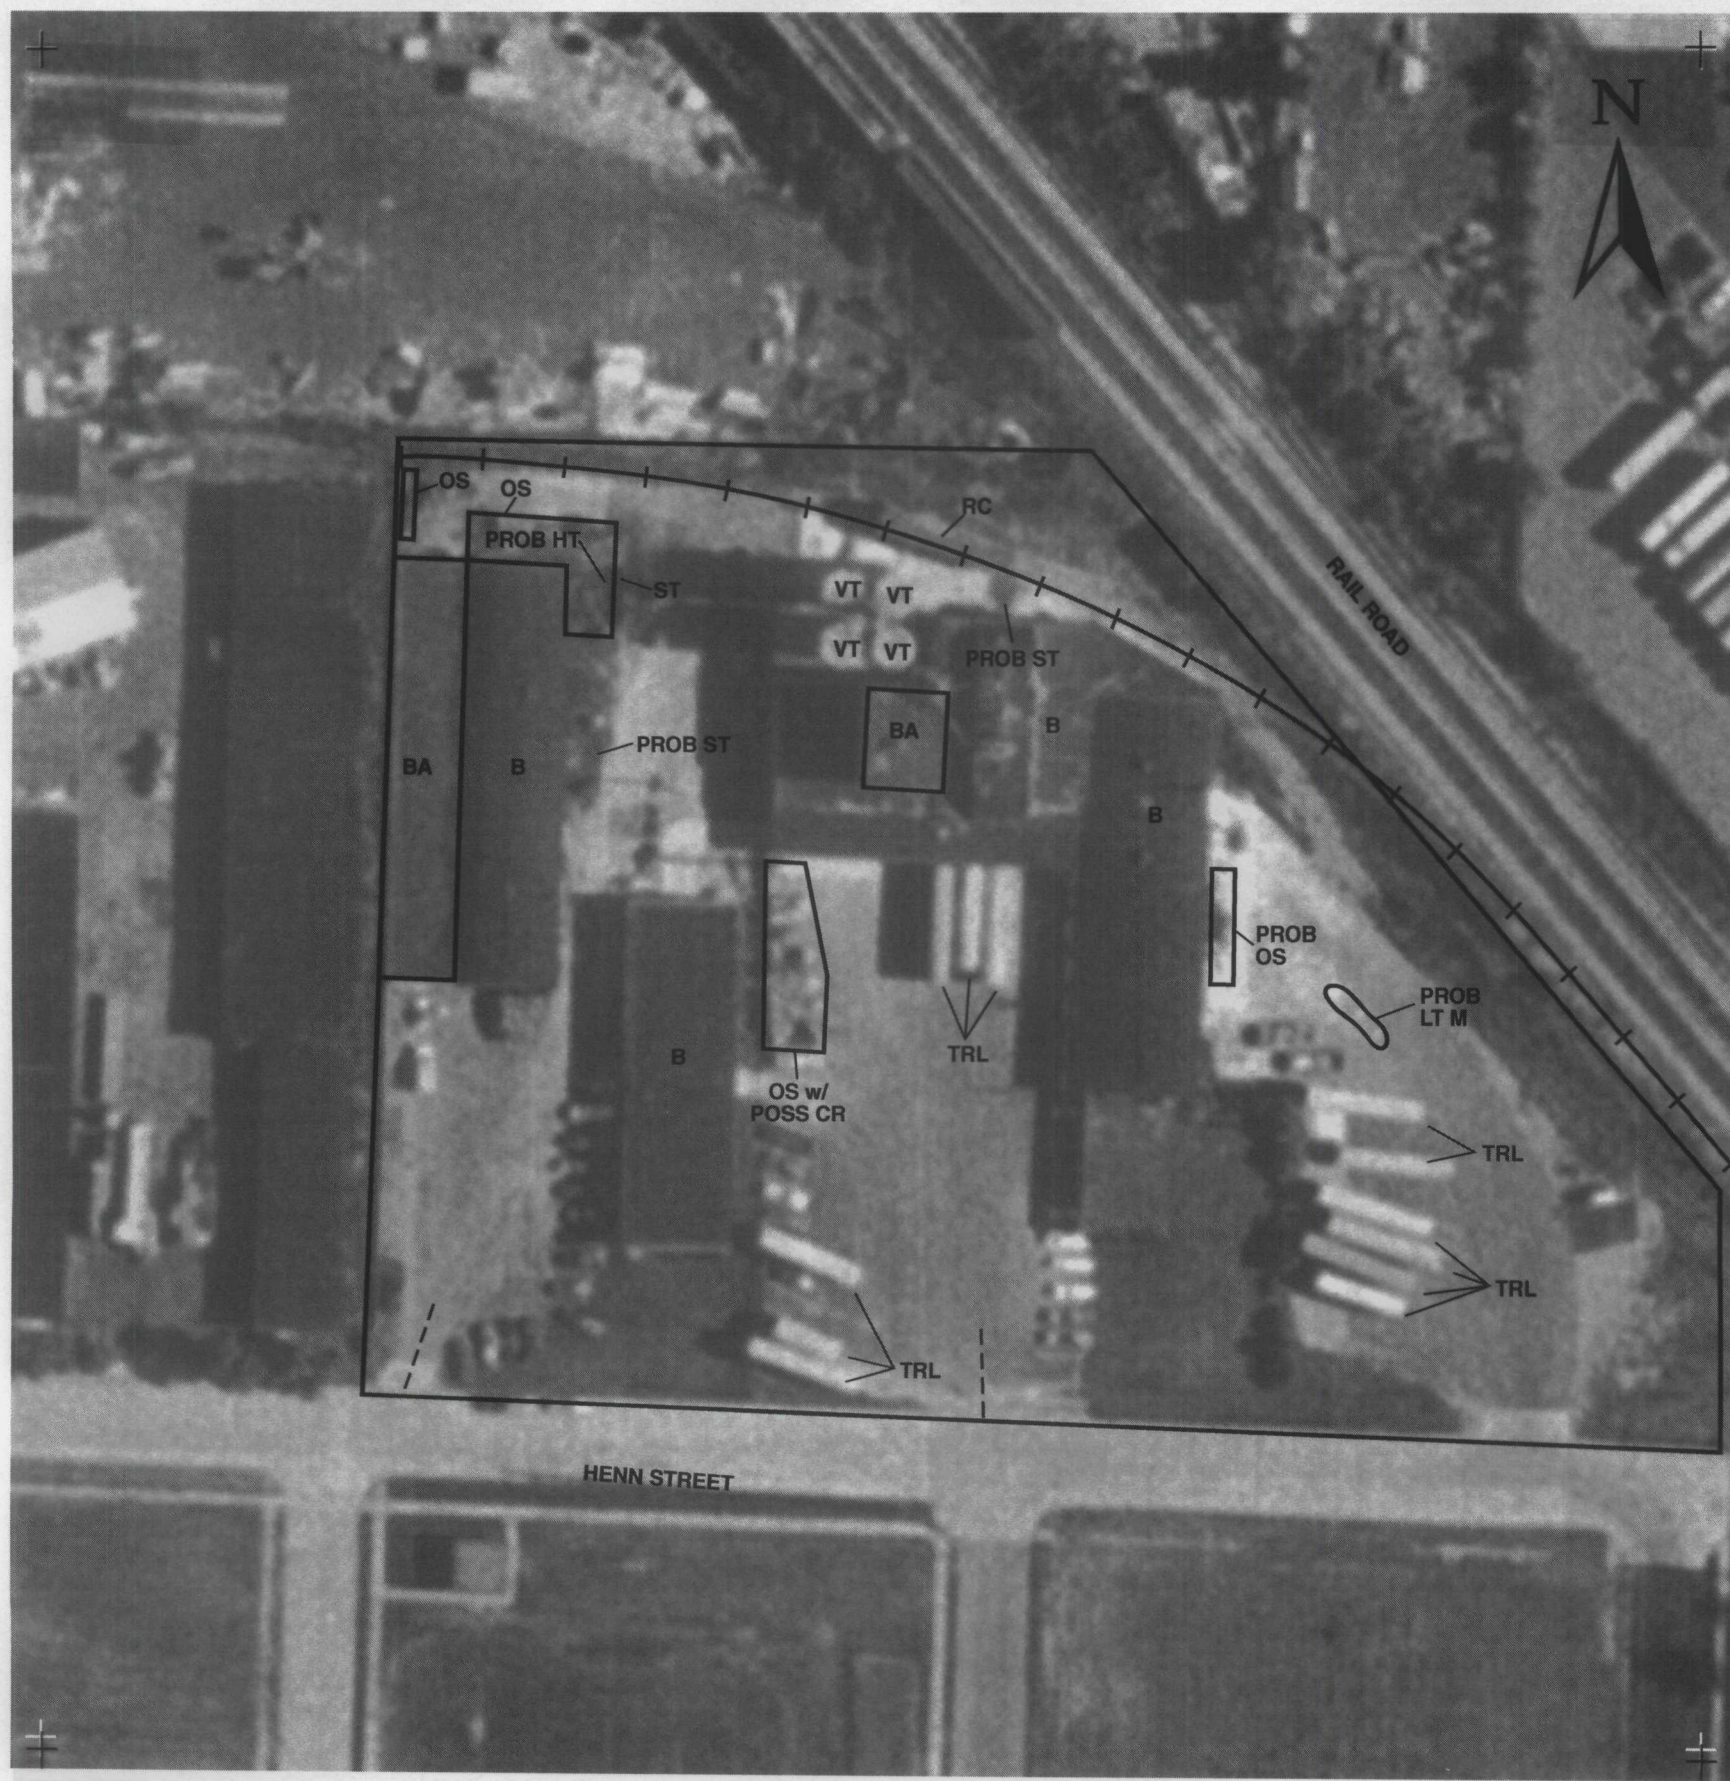
FIGURE 10
N-FORCER SITE

JUNE 11, 1980 (FIGURE 10)

A building addition has been constructed on the production facility where a portion of the roof was noted as having been removed on the 1978 photograph (FIGURE 9). A probable stain is seen between the northern side of the production facility and the rail spur. A probable open storage area containing unidentified objects (not annotated) is visible adjacent to the eastern side of the production facility. Three trailers, probable light-toned material, and an open storage area containing possible crates are noted in the parking lot (not annotated) to the south of the production facility.

A total of six trailers are observed to the southeast of the production facility and three trailers are seen in the southern portion of the site.

The building in the northwestern portion of the site has had a building addition constructed on its western side, where a possible open storage area was noted on the 1978 photograph (FIGURE 9). A small open storage area containing unidentified objects is visible to the north of this building addition. Further to the east, an open storage area containing a probable horizontal tank (HT) and unidentified objects (not annotated) is noted. Staining is visible in the vicinity of this probable horizontal tank and probable staining is observed to the south.

The rail spur noted in the southeastern portion of the site since 1951 (FIGURE 5) is no longer present. One railcar is visible on the remaining rail spur.

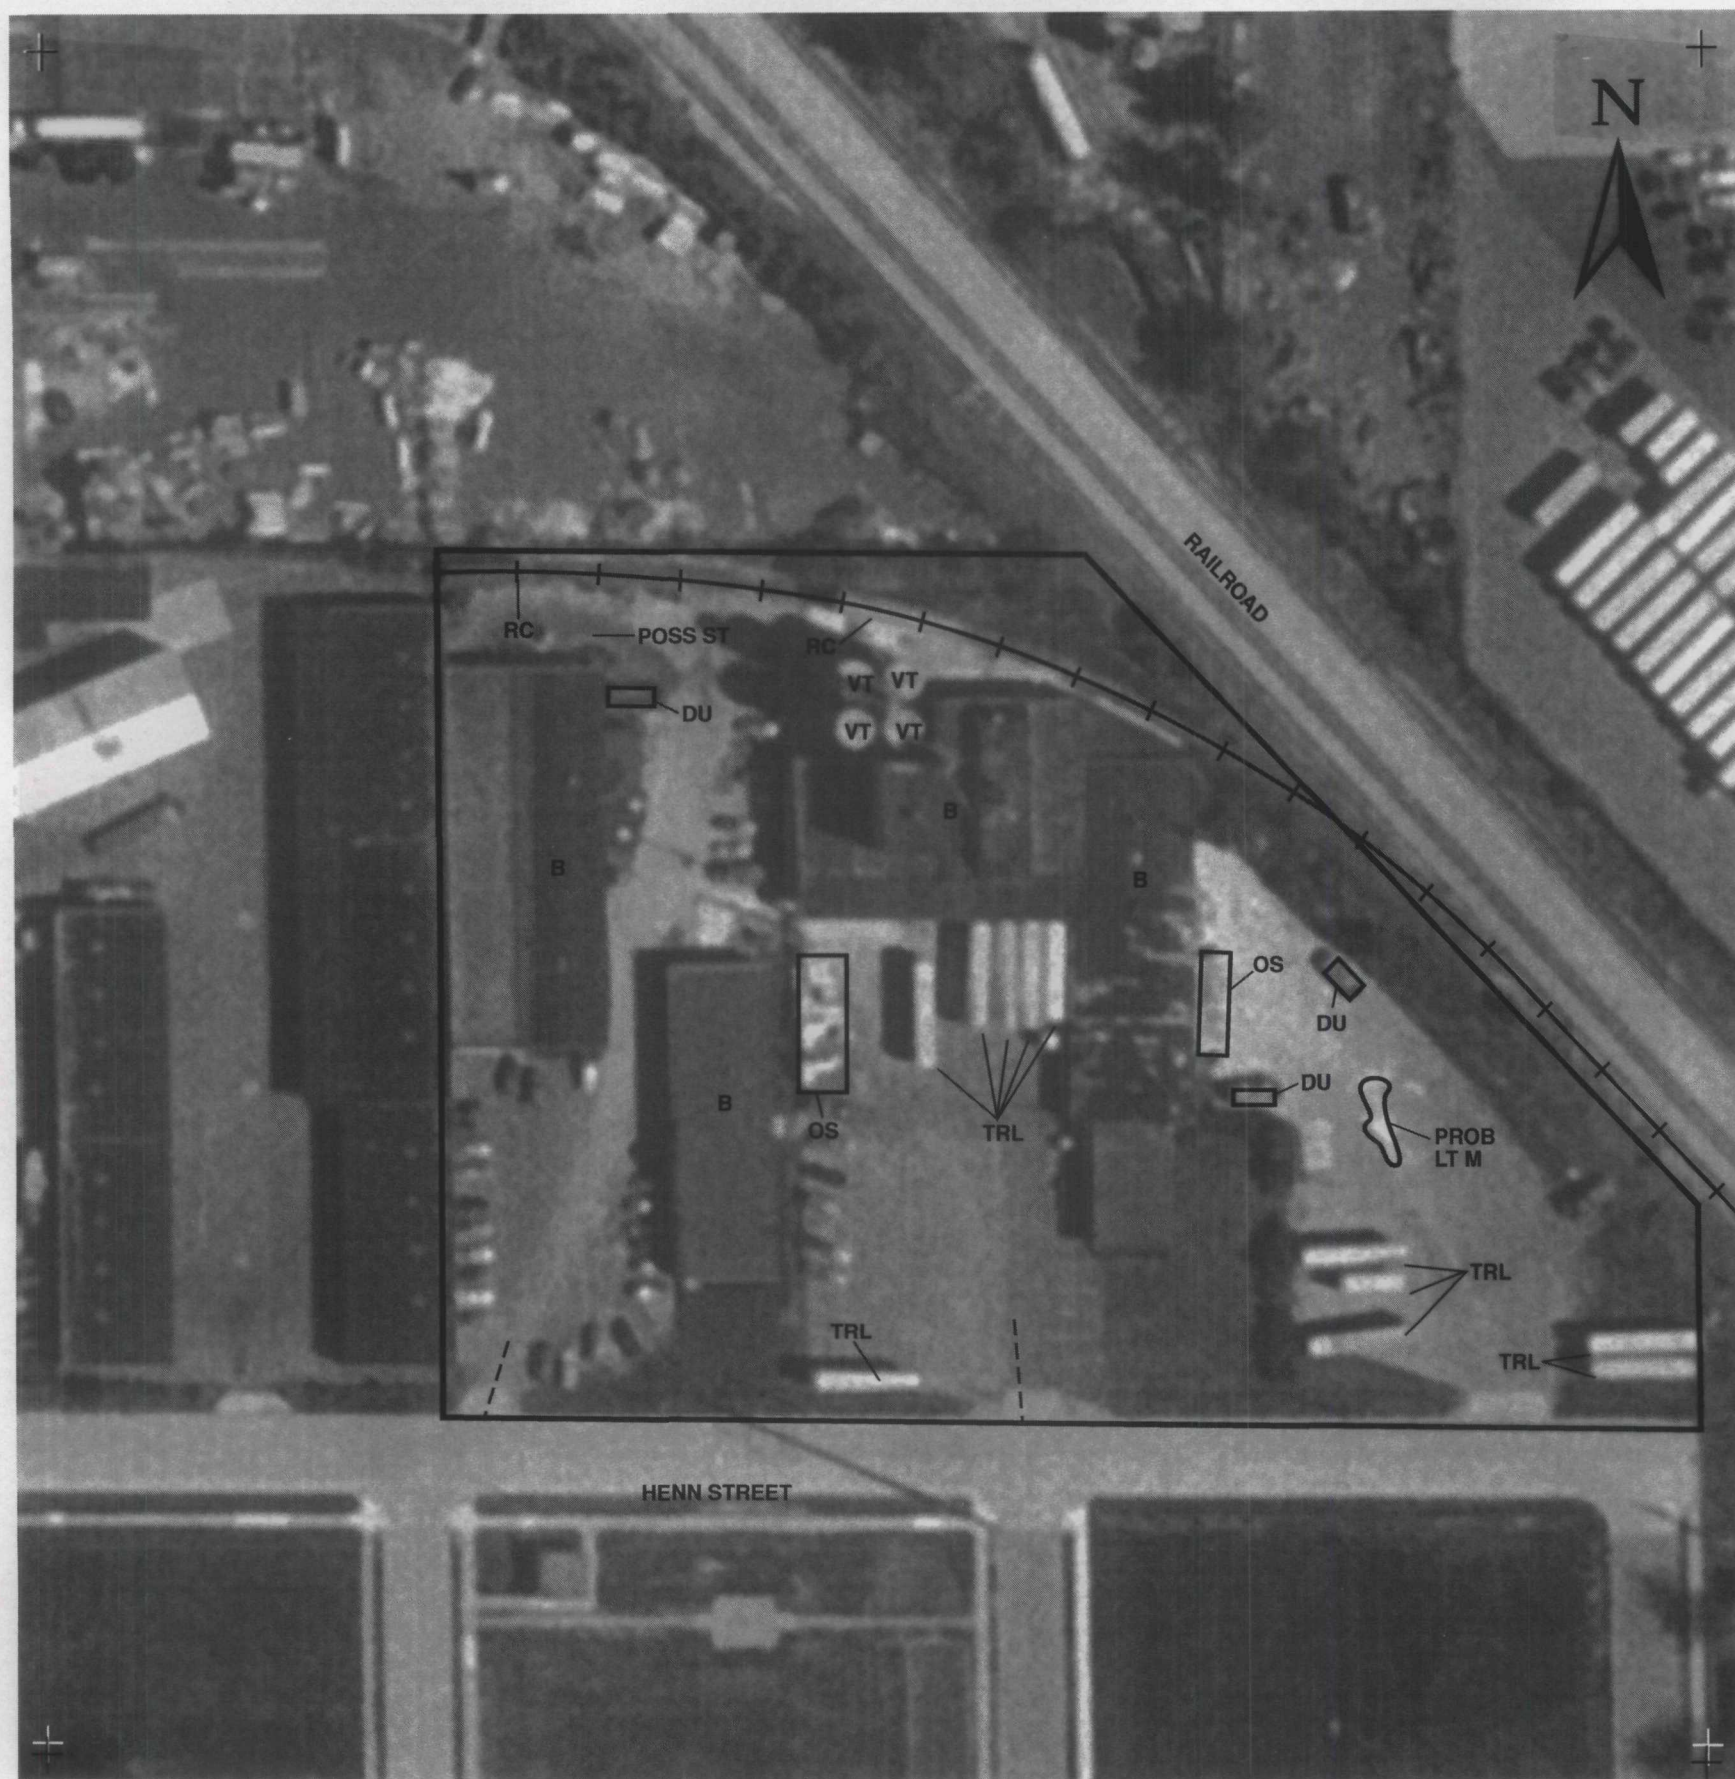
FIGURE 11
N-FORCER SITE

MAY 8, 1985 (FIGURE 11)

An open storage area containing unidentified objects (not annotated) is seen adjacent to the eastern side of the production facility. Two dumpsters and probable light-toned material are visible further to the east and southeast. Five trailers and an open storage area are noted in the parking lot (not annotated) to the south of the production facility. One trailer is visible in the southern portion of the site and a total of five trailers are seen in the southeastern portion of the site.

In the northwestern portion of the site, possible staining and a dumpster are observed adjacent to the northeastern corner of the building.

Two railcars are seen on the rail spur.

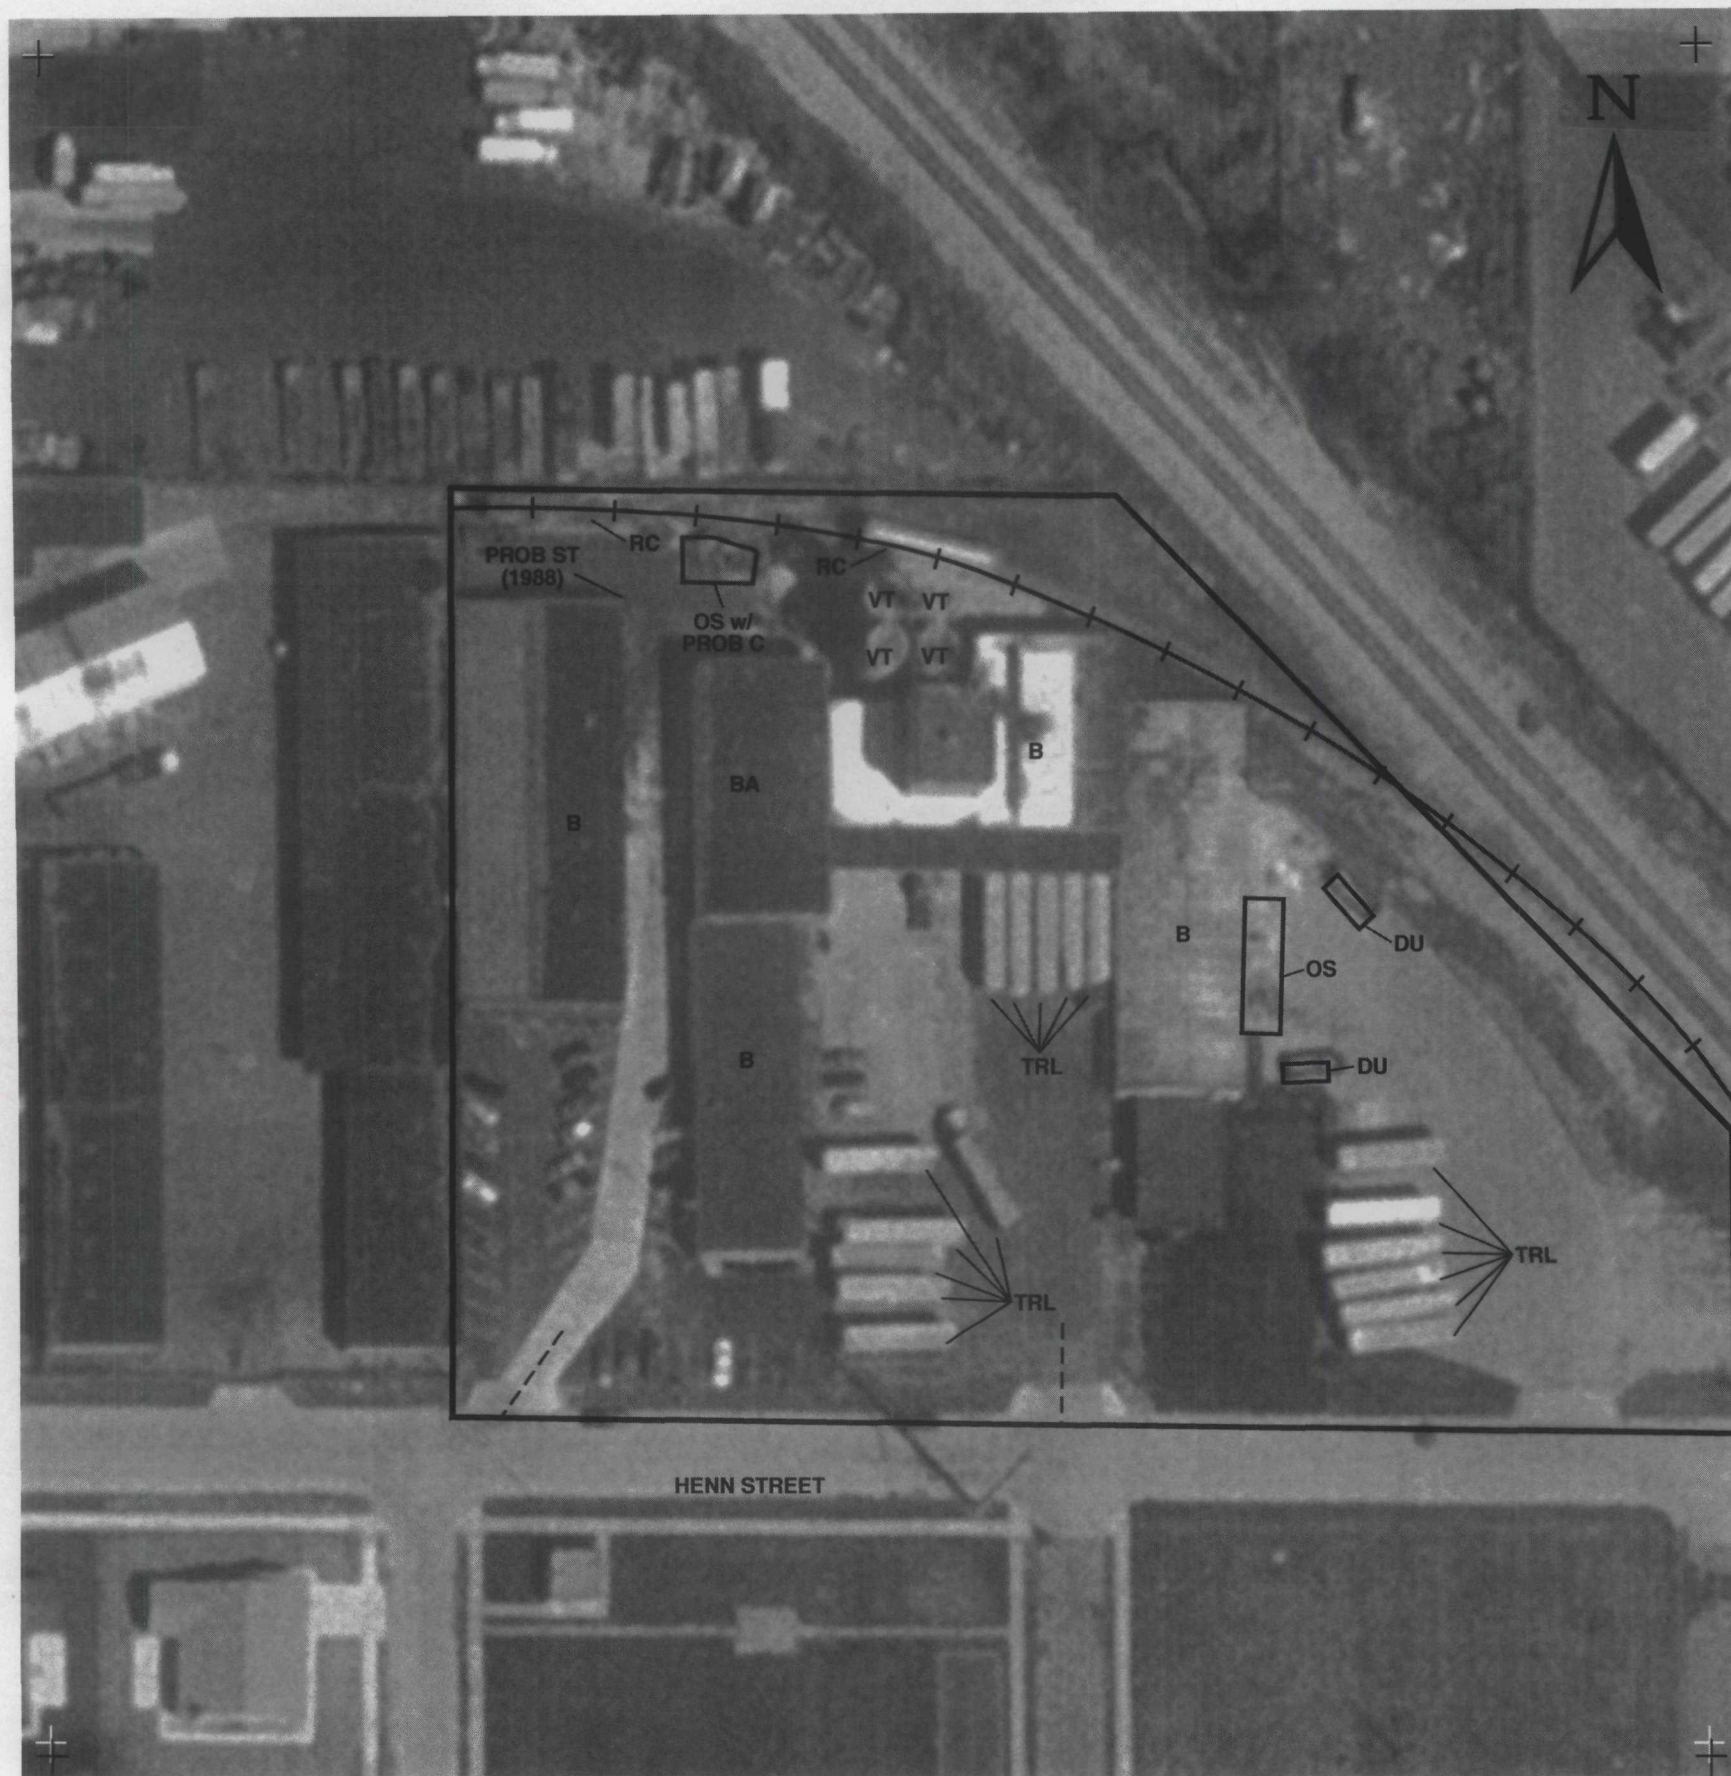
FIGURE 12
N-FORCER SITE

APRIL 18, 1990 (FIGURE 12)

A building addition links the western end of the production facility to the building in the south-central portion of the site. The light-toned area visible on the roof of the production facility on this photograph appears to be the natural tone of the roofing material and not related to the light-toned materials previously noted on site or to fugitive dust. An open storage area containing unidentified objects (not annotated) is visible adjacent to the eastern side of the production facility. Two dumpsters are noted further to the east. A group of five trailers is seen adjacent to the southern side of the production facility. Two groups of six trailers each are present; one is located in the southern portion of the site and one in the southeastern portion of the site.

An open storage area with probable containers is visible to the north of the building addition. Further to the west, probable staining was noted on the 1988 photographs (not reproduced for this report), in an area where possible staining was noted in 1985 (FIGURE 11) however, no staining was visible in 1990.

Two railcars are visible on the rail spur.
